**Seagate Inspections, Inc.**  
**8860 Airport Hwy.**  
**Holland, OH 43528**

**Washington Township, Board of Trustees**  
**5714 Blessing Dr.**  
**Toledo, OH 43612**

*Commercial - REPORT IS NOT TRANSFERABLE*

# Inspection Summary

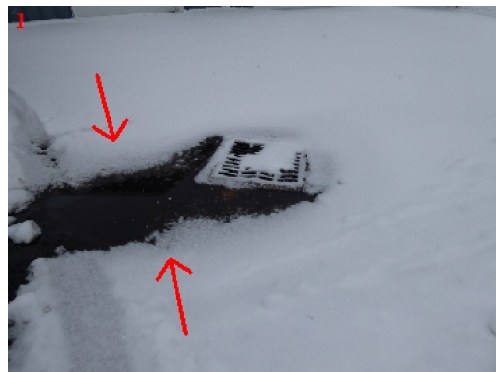
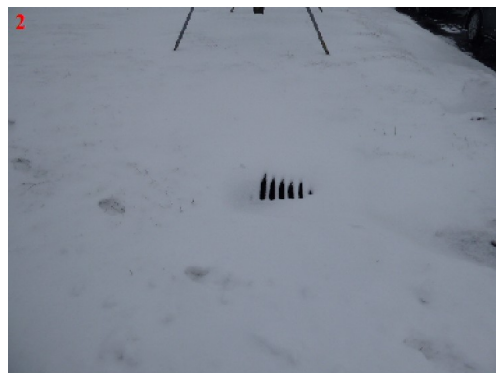
Storm water from the property appears to flow to the municipal storm water system. Some suspected wash out or erosion near catch basins will allow water to pool at and around the grate rather than freely flow into the drain. when conditions permit, soil / gravel / asphalt should be filled in to eliminate low ponding areas.

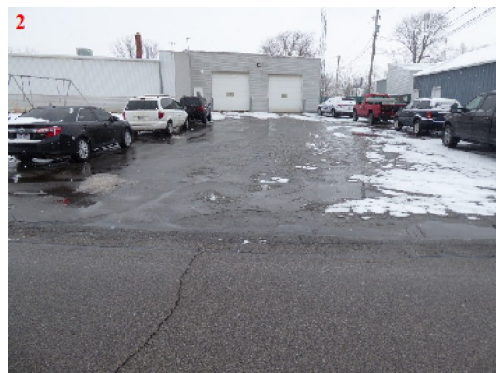
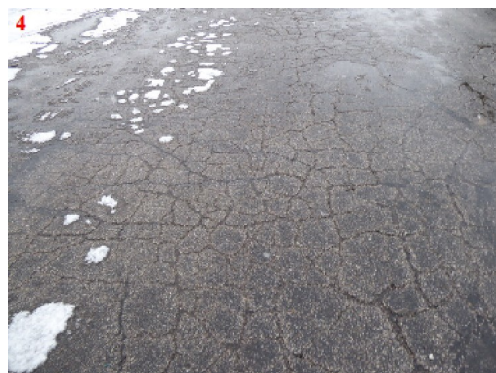
Driveway and parking areas are paved with asphalt. Though snow cover limited the overall visible access to the paved areas, cracking and settlement is readily visible in the exposed to view paved surfaces that will require repair. Repairs will include section replacement where deterioration and excessive cracking has occurred.

There appears to be adequate security lighting for the property. Additional lighting may be desirable to increase surface and area lighting.

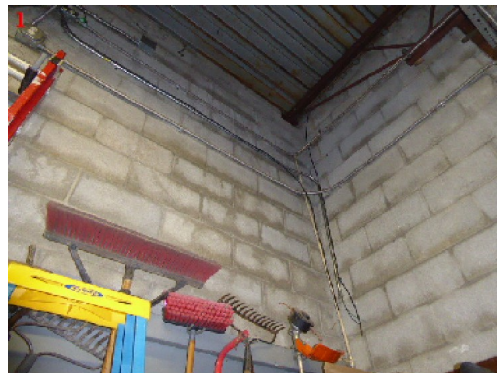
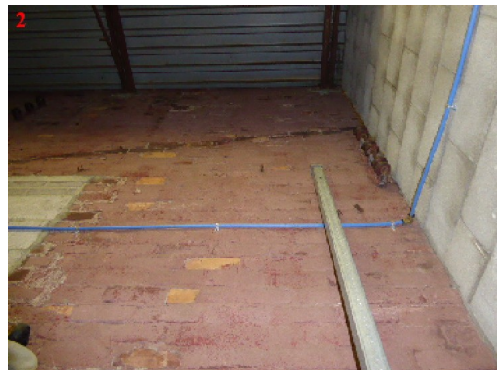
Moisture related staining and efflorescence is visible on the interior block and brick wall surfaces in the north garage. This is likely a result water running off the roof and behind the cladding / siding.

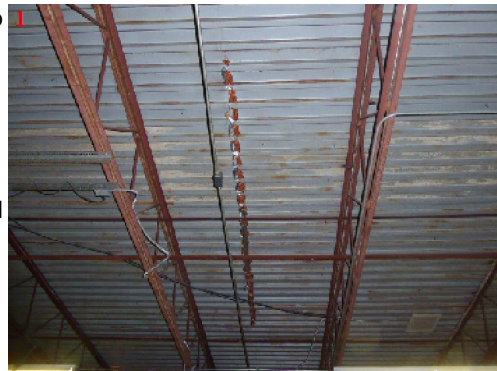
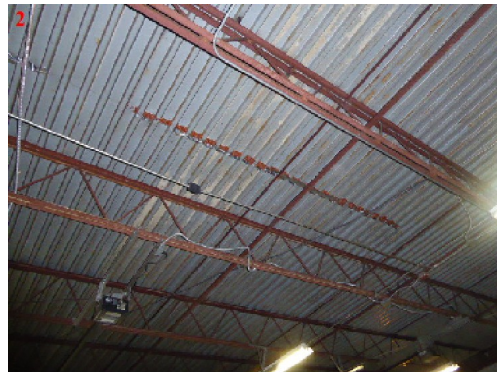
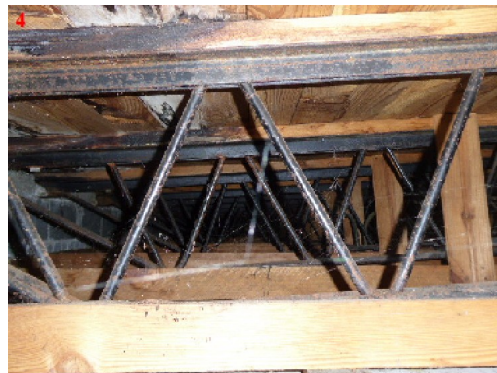
There have been attempts to stop leakage in both roof deck types. The north garage/shop has a material seam that was taped and filled with expanding foam. (Photos 1,2 & 3)

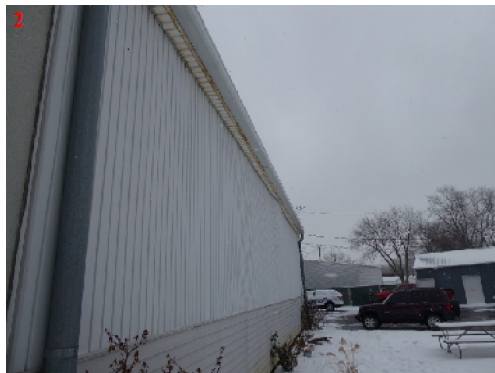
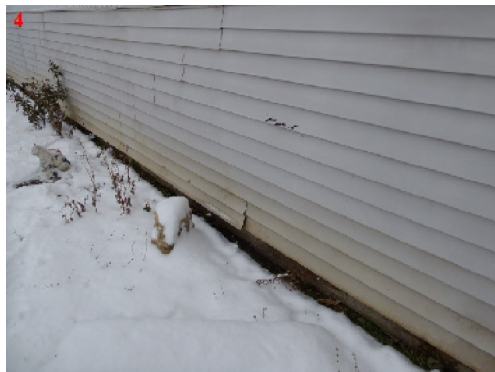
There is visible vinyl siding damage in multiple areas as well as some loose sections of vertical siding on the south side. It may be that the furring used to secure the vinyl siding to the block walls has gotten wet causing it to bow and exert pressure from behind the siding. Removal of the siding on the south side is going to be required to exact a proper repair. There are additional areas where the vinyl siding has been damaged.

Expect that contractors will propose complete replacement as removal and reinstallation of siding may not be feasible due to existing damaged panels and others that may be damaged in the process of removal to make repairs.

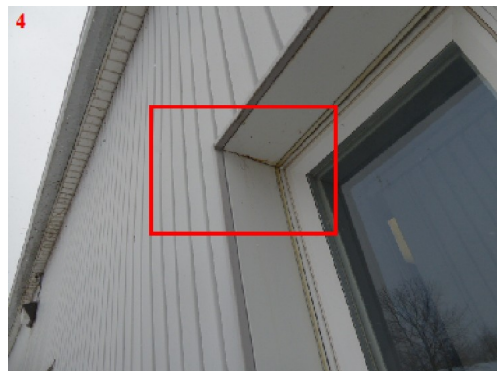
Rust can be seen on some of the windows, particularly on the northwest corner office window. It appears the steel lintel installed over the window penetration is rusting and causing the discoloration of white trim wrap at the window. Based on not being able to see the actual lintel due to the siding application, it is suspected that the lintel is heavily rusted and expanded. There is evidence inside and opposite of the northwest corner window of moisture related staining and damage. With continued rusting the steel will expand and can cause structural cracking in the block and brick walls. This area should be further evaluated and unfortunately it can only be evaluated by removing siding in the area to expose the steel lintel and adjacent wall.

Exterior pass doors are a combination of wood core with steel skins and all steel doors. Rusted door frames at grade level are fairly wide spread and if not already doing so, can allow access to small rodents etc. Water seepage into any openings at the base of these doors will only accelerate the rusting of the door frames.

Replacement of the doors with the worst damage is recommended along with maintenance of doors that can benefit from prepping and repainting where rust through has not yet occurred.

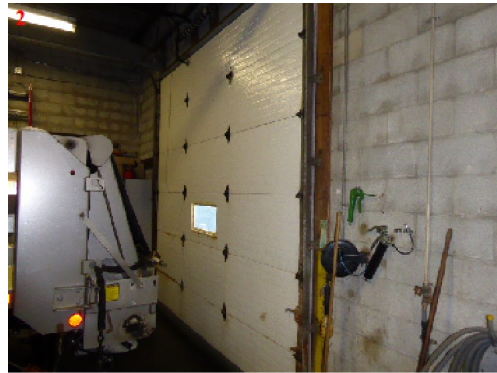
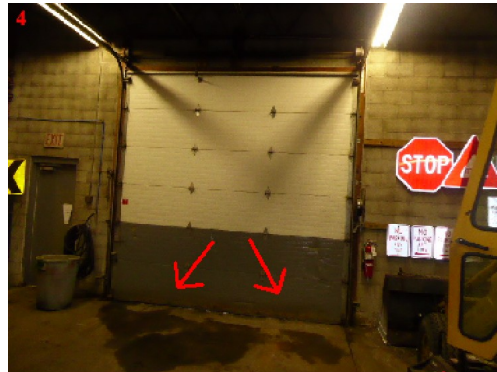
Multiple overhead doors are installed and most show signs of age related damage somewhat typical of a facility such as this. There are doors with more damage and rust than others that carry an elevated risk of potential segment collapse where panels have rusted and / or are creased.

The two doors at the south garage bay area were not opened due to their automatic openers being unplugged from power.

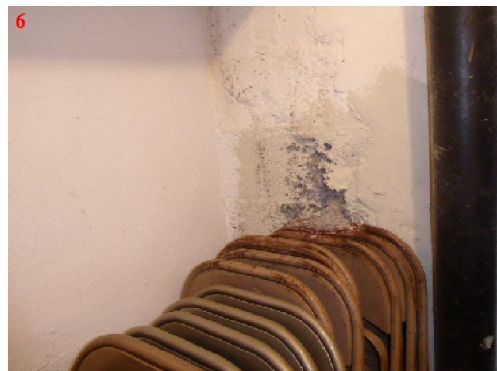
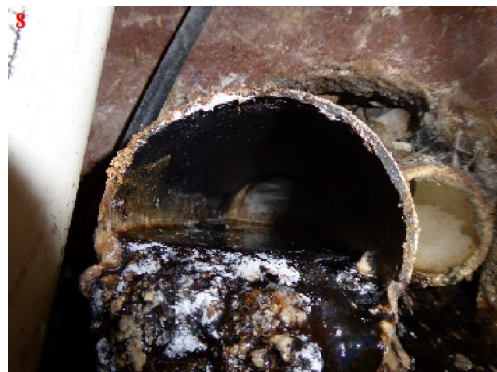
There was moisture / dampness evidence observed in the basement at the time of the on-site assessment. Foundation block spalling along the stairway wall leading to the basement as well as efflorescence in multiple areas of the basement are readily visible signs of a moisture seepage concern. The most probable sources of this moisture intrusion include inadequate roof and exterior surface water controls. Make improvements to the grading, downspout discharge, etc... before considering more invasive and expensive measures.

There was an attempt to on / off test the sump pump. The sump pump operated as expected however the drain tiles that discharge into the crock are nearly blocked with a soil borne fungus. In some cases iron fungus can morph into a more gelatinous substance that is known to severely limit flow of water through the drain tiles. In the short term, water jetting the drain tiles is highly recommended. The installation of at least a single clean out in the opposite corner of the basement from the sump crock is also advised to allow for periodic chlorine treatments to control fungus growth. When the tiles cannot carry water unrestricted to the sump crock, the tiles will fill and water will seep in along the floor and foundation around the basement perimeter. It appears there is a partial water channeling system installed.

Based on the available evidence at the time of the on-site assessment, there is a medium to high probability of future below grade seepage. Recommendations listed in this section as well as sections dealing with any exterior components of the property should taken into strong consideration.

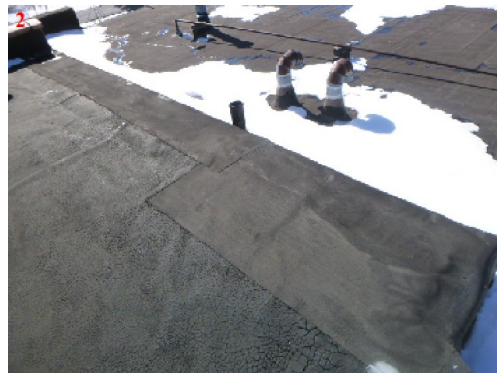
Evidence of multiple layers of roofing tar and felt over the wood and metal roof decks was observed. The added weight of additional layers can eventually have an adverse affect on the structural integrity of the roof, especially if and when combined with heavier wet snow loads.

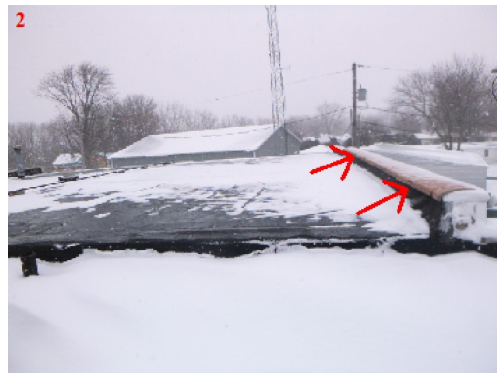
Asphalt patch used as flashings will require maintenance. The parapet wall coping is terra cotta and in some instances shows signs of age related cracking and displacement.

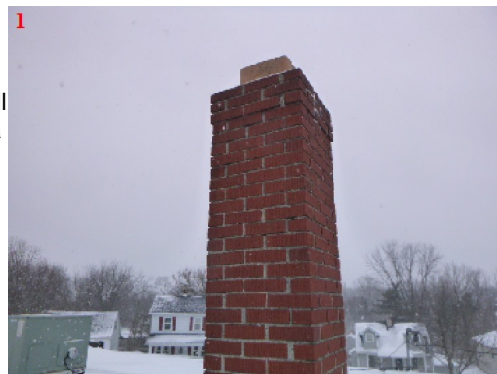
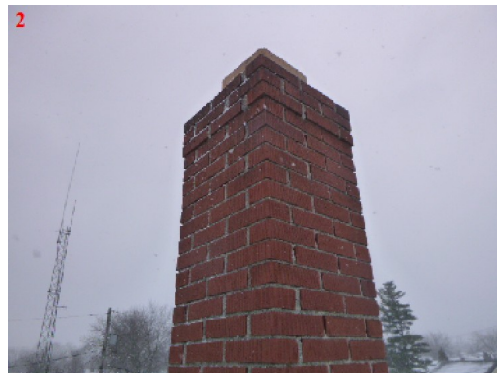
There is a crack visible in the top section of the clay flue liner as well as the masonry crown. The installation of a rain cap is advised as a way to limit moisture entry into the chimney flue that can have a detrimental affect on integrity. Any cracks in the masonry chimney crown / cap should be sealed for similar reasons.

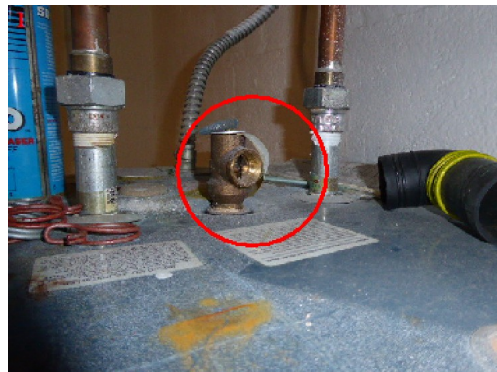
There should be an extension pipe installed on the water heater's temperature - pressure relief valve that discharges to within six inches of the floor to avoid uncontrolled discharge in the event the valve is called on to operate.

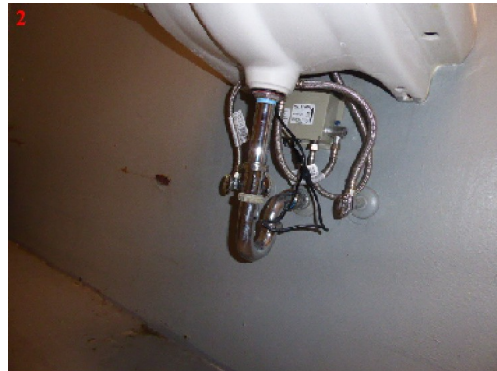
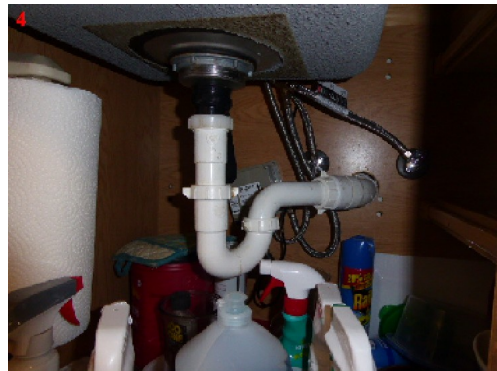
There is evidence of past leakage (staining) at various sink drain traps. No moisture was observed at the time of the onsite assessment. Amateur repair / installation using electrical tape was observed at the coffee area sink.

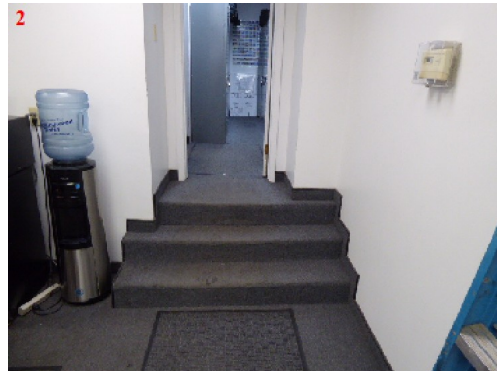
Railings are generally required where there are three or more stair rises. For safety of those using any of the building's stairways, railings should be installed.

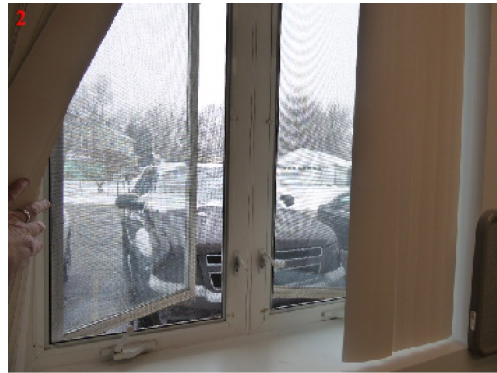
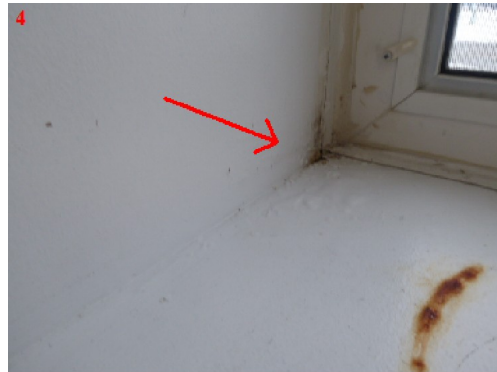
Windows on the north wall show signs of leakage and surface damage to the sill area. These stained areas were dry at the time of the on site assessment.
