**Seagate Inspections, Inc.**  
**8860 Airport Hwy.**  
**Holland, OH 43528**

**Washington Township, Board of Trustees**  
**5714 Blessing Dr.**  
**Toledo, OH 43612**

*Commercial - REPORT IS NOT TRANSFERABLE*

# Inspection Summary

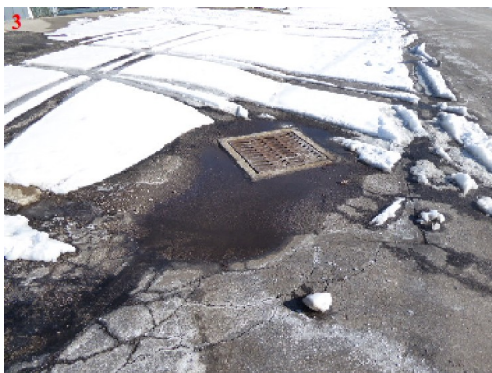
Storm water from the property appears to flow to the municipal storm water system. Some suspected wash out or erosion near catch basins will allow water to pool at and around the grate rather than freely flow into the drain. when conditions permit, soil / gravel / asphalt should be filled in to eliminate low ponding areas.

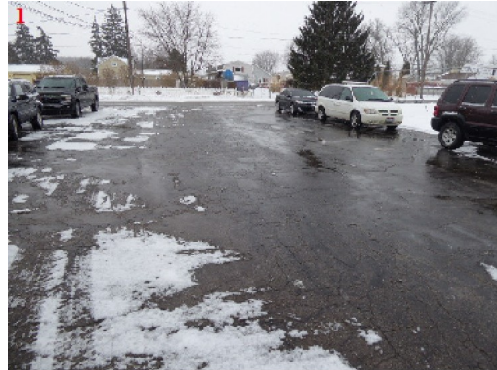
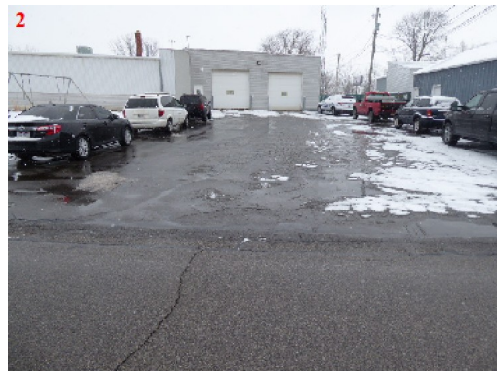
The property is situated on a corner lot with access available from multiple points off Blessing Dr. and David Dr.

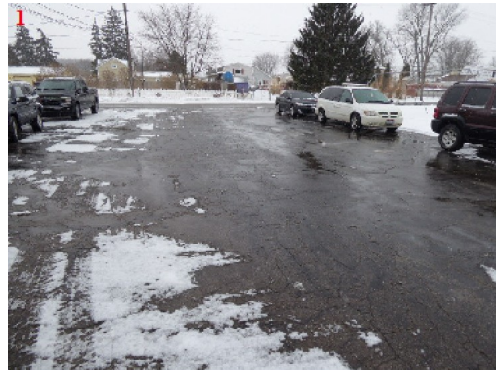
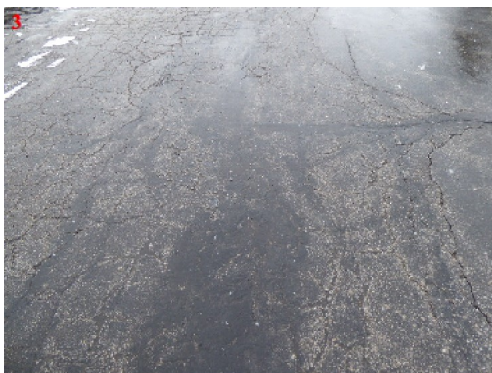
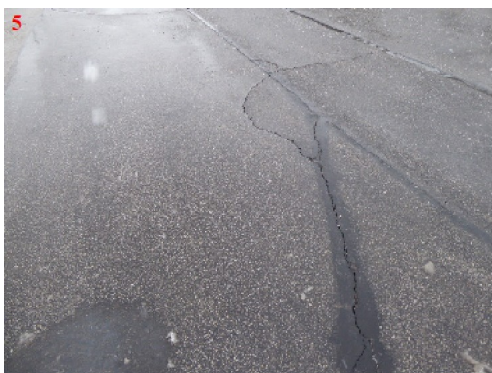
Driveway and parking areas are paved with asphalt. Though snow cover limited the overall visible access to the paved areas, cracking and settlement is readily visible in the exposed to view paved surfaces that will require repair. Repairs will include section replacement where deterioration and excessive cracking has occurred.

There appears to be adequate security lighting for the property. Additional lighting may be desirable to increase surface and area lighting.

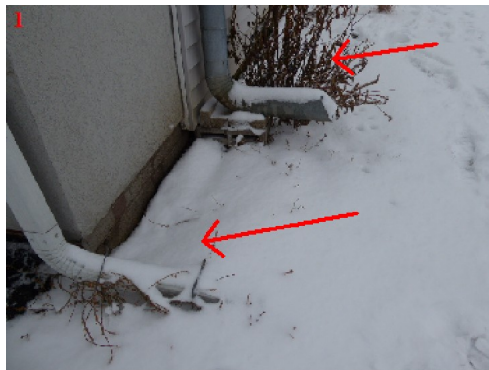
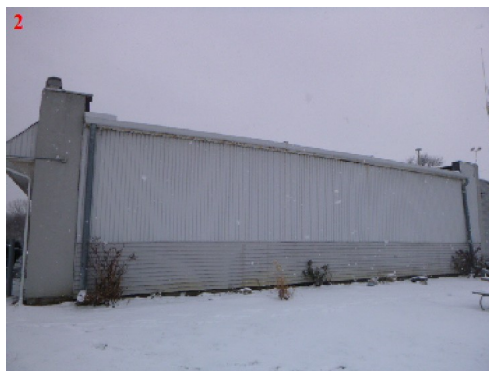
Based on interior below grade evidence as well as visual evidence of settled soil along the building's perimeter walls, some improvement is needed in the landscape grading around the building. The objective is to get the soil built up at the foundation, while still maintaining a good amount of clearance from structural framing and/or siding, to a level and angle or slope that promotes good surface water run-off away from the foundation. This is typically considered part of routine upkeep and should be monitored and improved where and when needed.

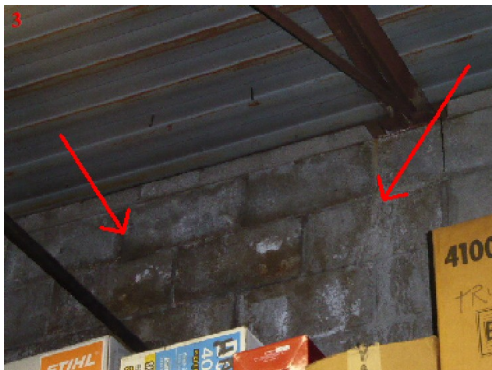
Moisture related staining and efflorescence is visible on the interior block and brick wall surfaces in the north garage. This is likely a result water running off the roof and behind the cladding / siding.

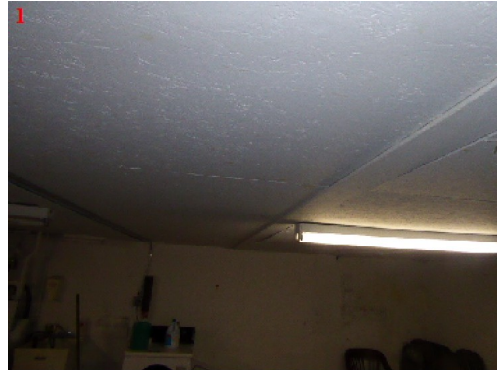
Where concrete floor structure is noted, the floor is typically reinforced for strength. The floor structure above the basement ceiling was covered with painted OSB and it's structural makeup was unable to be positively determined

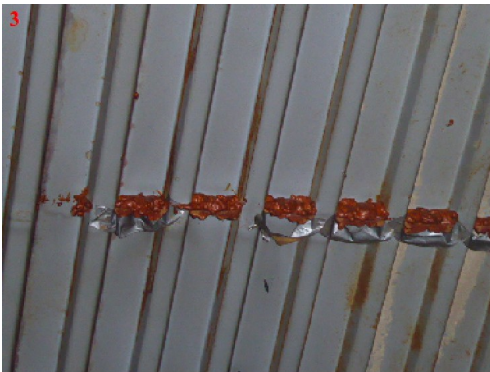
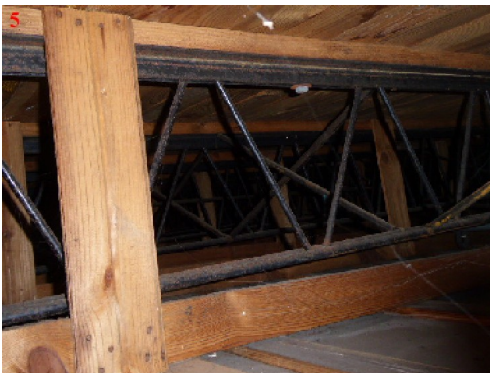
There have been attempts to stop leakage in both roof deck types. The north garage/shop has a material seam that was taped and filled with expanding foam. (Photos 1,2 & 3)

The wood plank roof deck over the office space, common areas and south garage is supported by open web steel trusses.

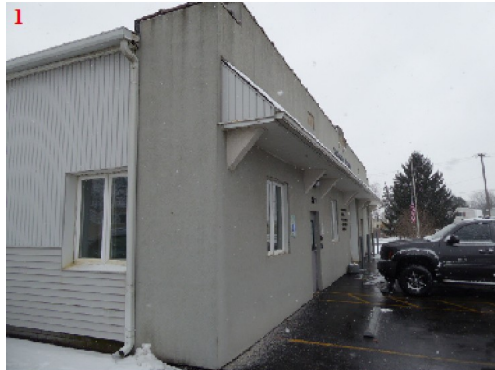
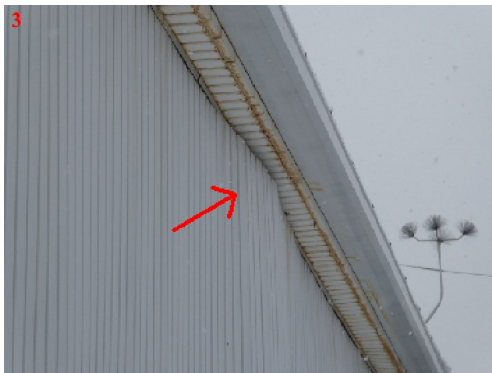
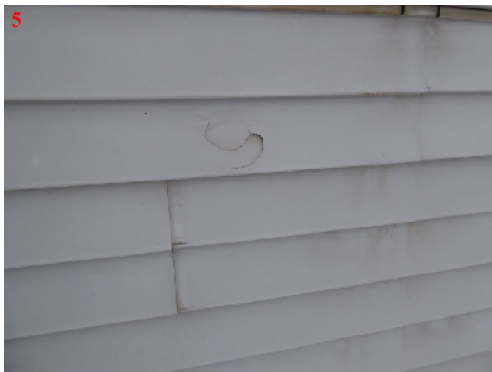
There is visible vinyl siding damage in multiple areas as well as some loose sections of vertical siding on the south side. It may be that the furring used to secure the vinyl siding to the block walls has gotten wet causing it to bow and exert pressure from behind the siding. Removal of the siding on the south side is going to be required to exact a proper repair. There are additional areas where the vinyl siding has been damaged.

Expect that contractors will propose complete replacement as removal and reinstallation of siding may not be feasible due to existing damaged panels and others that may be damaged in the process of removal to make repairs.

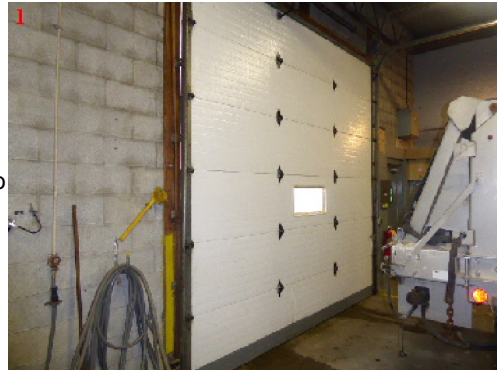
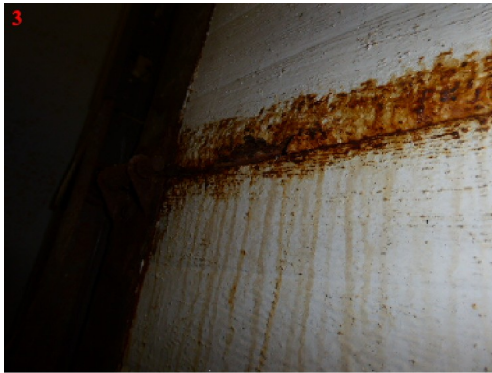
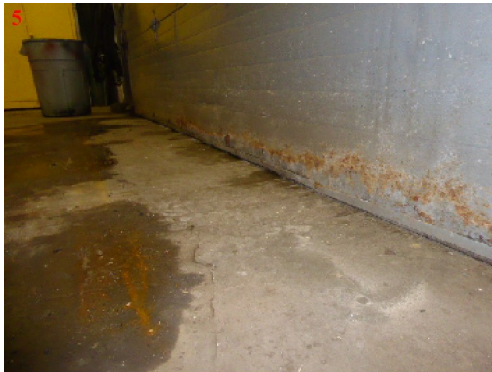
Multiple overhead doors are installed and most show signs of age related damage somewhat typical of a facility such as this. There are doors with more damage and rust than others that carry an elevated risk of potential segment collapse where panels have rusted and / or are creased.

The two doors at the south garage bay area were not opened due to their automatic openers being unplugged from power.

- Replacement of damaged overhead door panels to reduce the potential for sagging and related collapse (creased and or rusted panels):

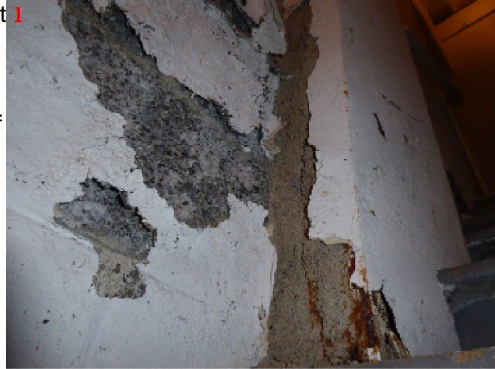
There was moisture / dampness evidence observed in the basement at the time of the on-site assessment. Foundation block spalling along the stairway wall leading to the basement as well as efflorescence in multiple areas of the basement are readily visible signs of a moisture seepage concern. The most probable sources of this moisture intrusion include inadequate roof and exterior surface water controls. Make improvements to the grading, downspout discharge, etc... before considering more invasive and expensive measures.

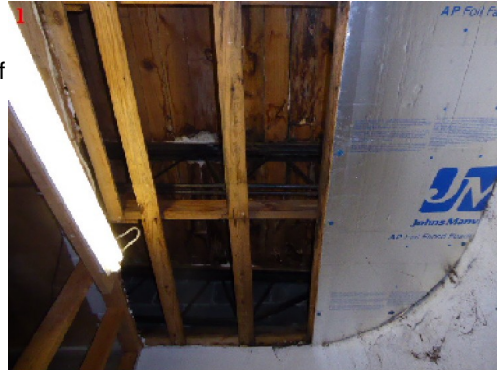
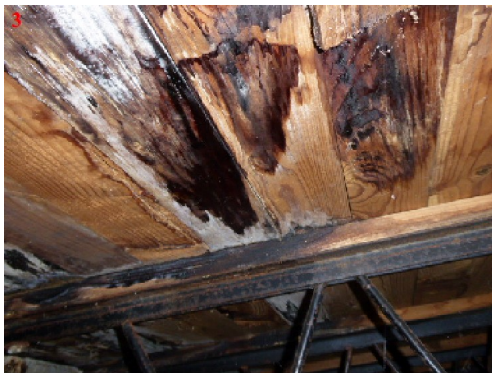
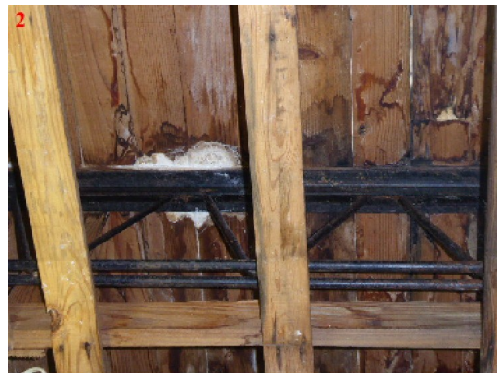
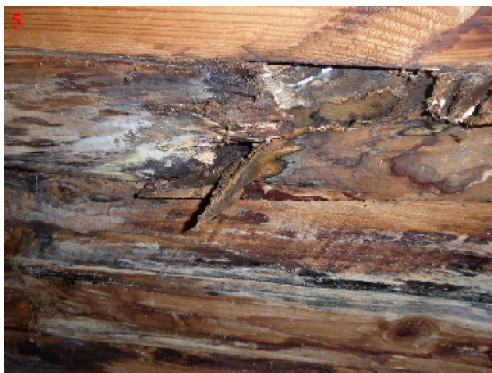
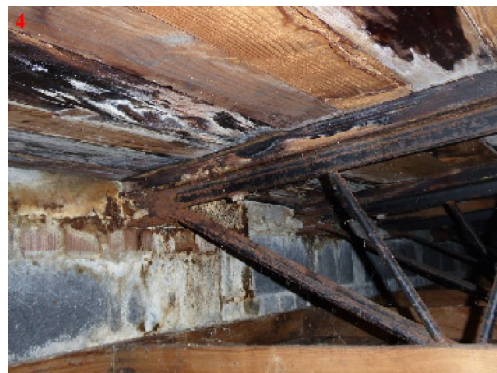
### Primary Concern General Structure Observations - Observation / Recommendation

Roof deck rot and decay visible from very limited areas leave room to speculate that similar conditions are fairly consistent and widespread. With the suspected history of roof leakage and the roof deck damage as well as rusting of open web steel roof trusses, it is our opinion the roof structure should be fully evaluated and all necessary repairs be made by a qualified contractor. Roof deck removal and replacement in those areas where rot and decay are considered substantial will need to be performed from above when the roof covering is torn roof and replaced.

Consulting with a qualified commercial roofing contractor for a full evaluation and repairs estimate is recommended.

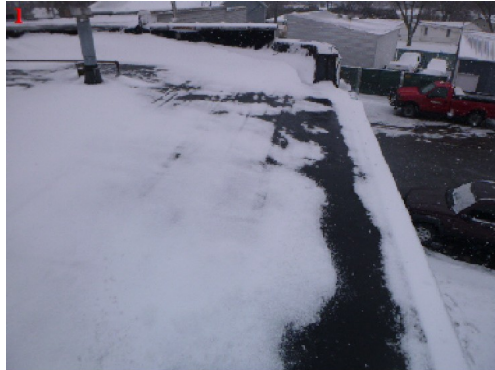
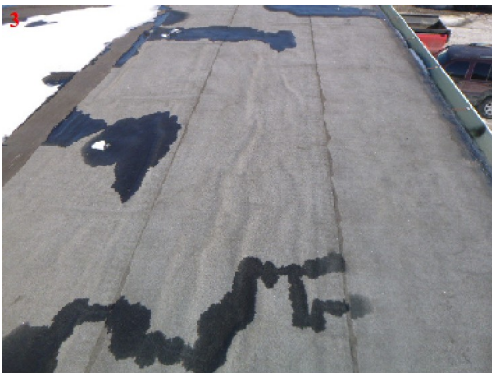
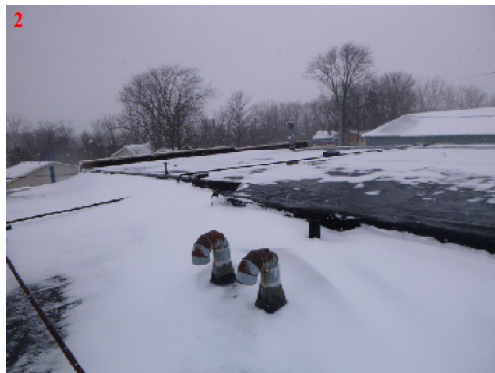
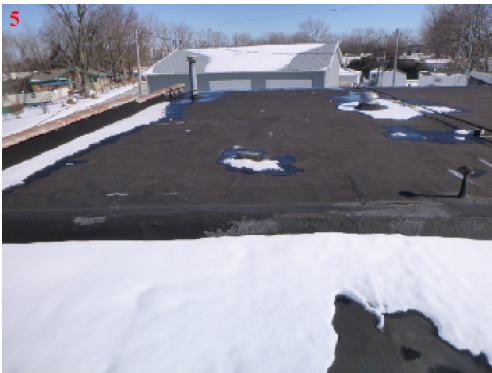
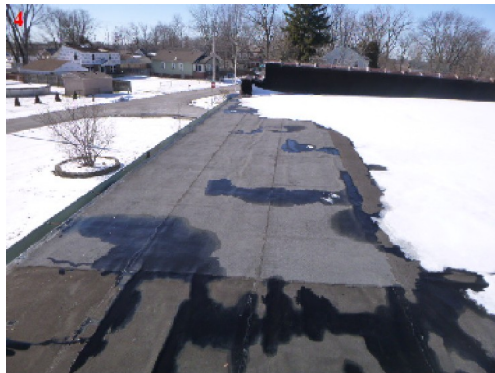
Note that multiple trips to the site were required in order to visually access the roof covering due to snowfall on the day prior to the scheduled condition assessment. Photos show the varying conditions from one visit to the next.

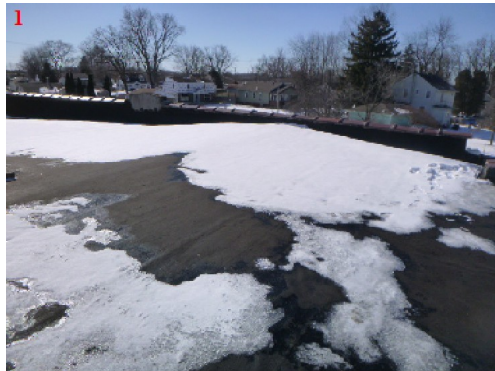
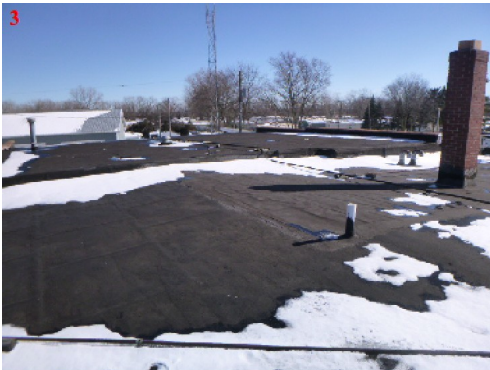
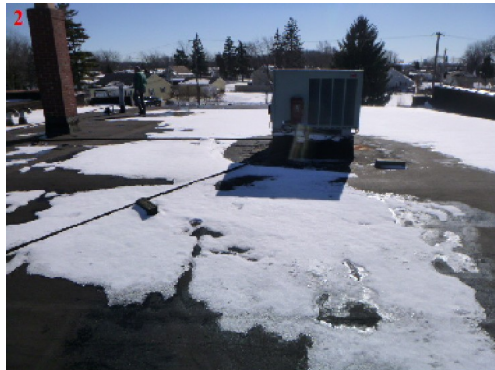
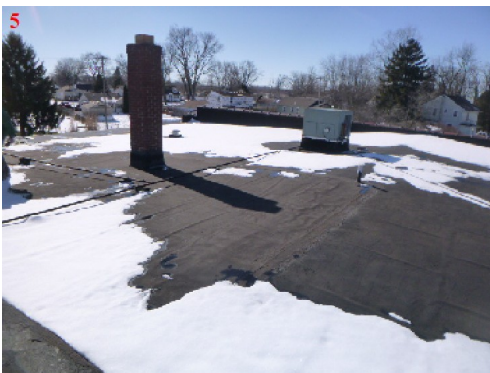
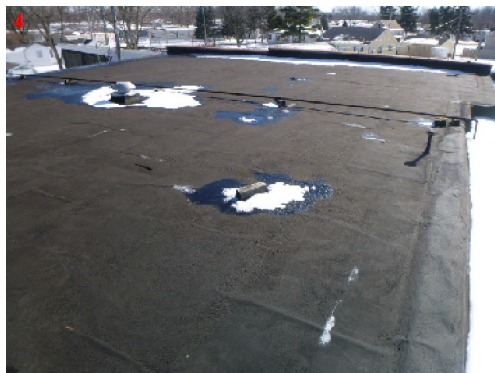
Snow covering on the roof surface at the time of the assessment restricts visible access to the roof covering by approximately 45%. Consider any information related to the roof itself as limited at best due to this condition.

Any future assessments by roofing contractors as a result of our recommendations are likely to lead to discovery of additional issues that simply were unable to be observed due to snow and ice cover.

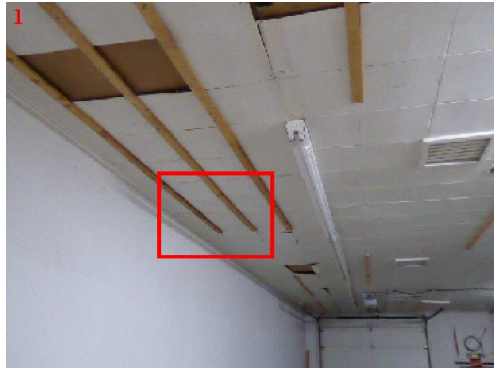
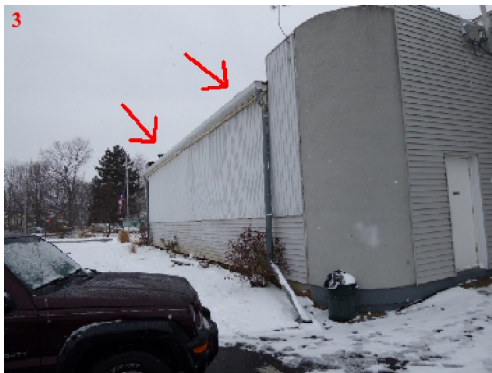
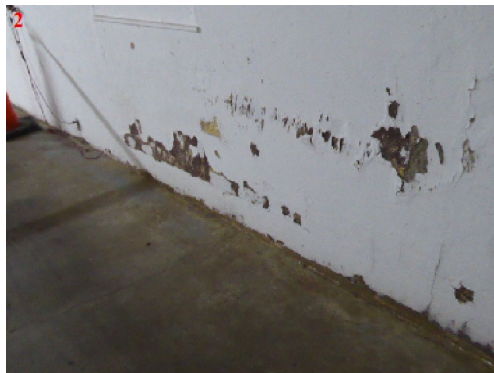
The gutter on the south side of the building and soffit both are showing signs of leakage and mismanagement of the roof water. Rusted surfaces on the soffit, measurable moisture on the interior wall and ceiling of the south garage area and staining on the floor inside the south garage are indicators that the gutter and even roof eave are in need of work. There are signs of past leak chasing that appear to have been unsuccessful in completely eliminating the concern. Roof eave work along with soffit and fascia repair, including the repair of potential for hidden damage, should be included with any future attention given to this building's roof. Refer to the interior IR report for additional detail related to moisture.

In addition there is visible damage at the northwest corner of the building where the gutter and roof eave detail allows water to freely bypass the gutter and run down the adjacent surfaces (photo 7). This may be in part, a contributing factor to the leakage at the corner of the office where the suspended ceiling is stained, stained surfaces at the corner office window are visible and the damage to the original acoustic tile ceiling above the suspended ceiling.

The gutter on the east side of the service shop is rusted and in some sections appears to be in various stages of being rusted through (photos 8 & 9).

It is recommended that where applicable, all above ground downspouts be extended at least six feet from the structure.

Repairs, section replacement other improvements should be carried out by a qualified roofing and gutter contractor.

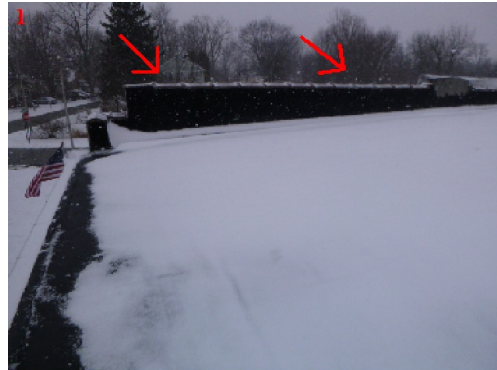
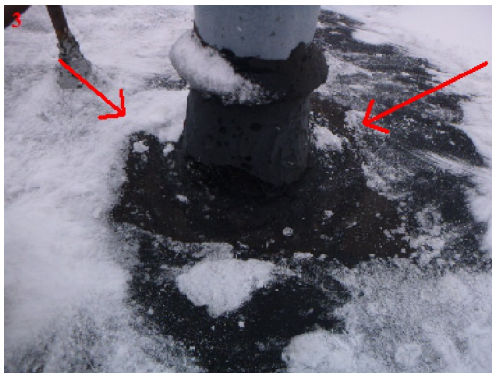
### Flashing - Asphalt, Caulk and Roof Sealer, Parapet Wall Cap

Asphalt patch used as flashings will require maintenance. The parapet wall coping is terra cotta and in some instances shows signs of age related cracking and displacement.

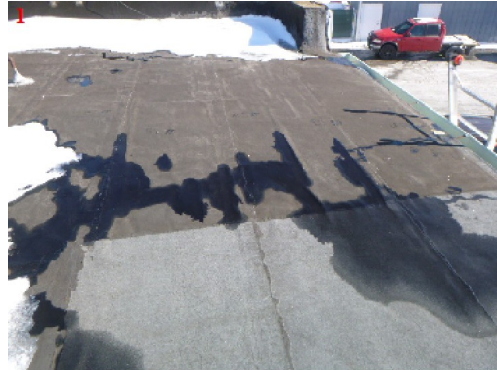
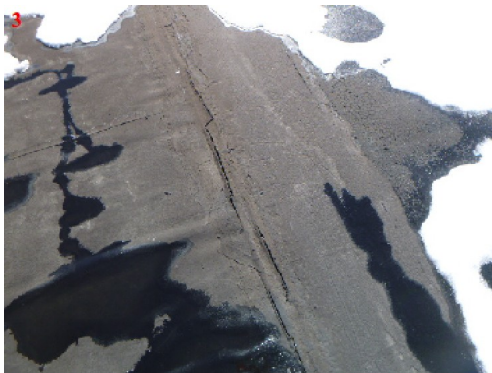
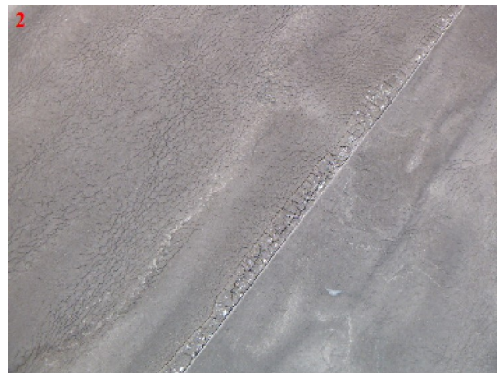
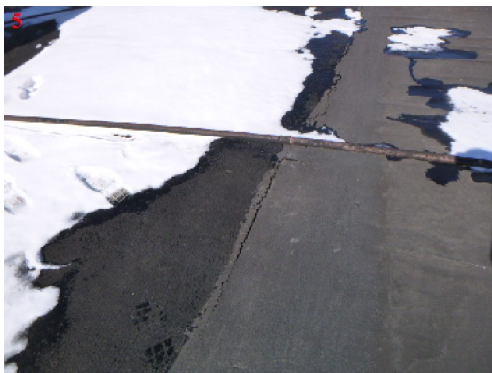
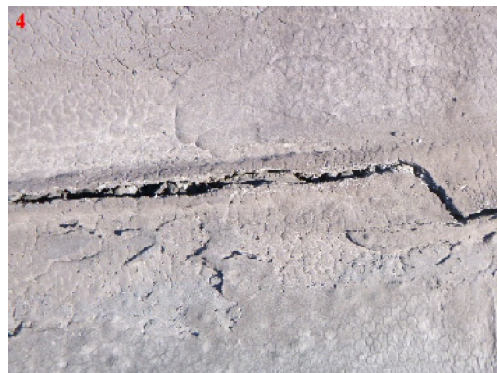
### Primary Concern General Roof Observations - Observation / Recommendation

Evidence of multiple layers of roofing tar and felt over the wood and metal roof decks was observed. The added weight of additional layers can eventually have an adverse affect on the structural integrity of the roof, especially if and when combined with heavier wet snow loads.

The visible condition of the roof is such that the entire roof system should be removed and replaced.

Replacement costs will include but not necessarily limited to roof covering tear off and replacement with upgraded insulation board, wood roof decking section replacement due to water damage, parapet wall coping repair/replacement and roof water drainage improvements.

Expect additional costs associated with tear off, haul away and disposal as the existing roof is likely to contain coal tar pitch and possibly asbestos, which will require specialized handling and personal protective equipment by workers.

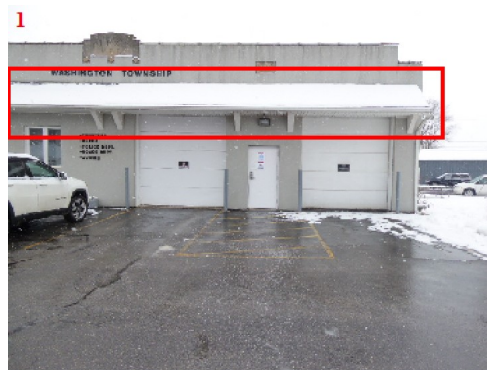
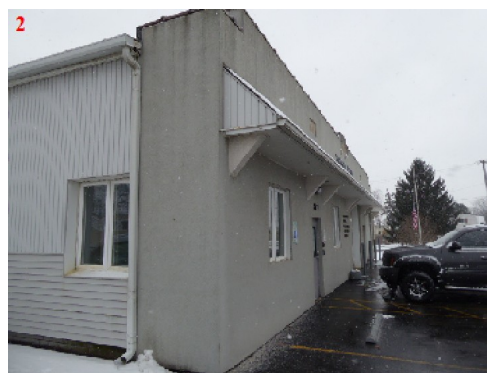
Snow covering on the canopy at the time of the assessment restricted visible access to the asphalt shingles. What sections were visible appeared to be in satisfactory condition. Consider any information related to the canopy roof itself as limited at best.

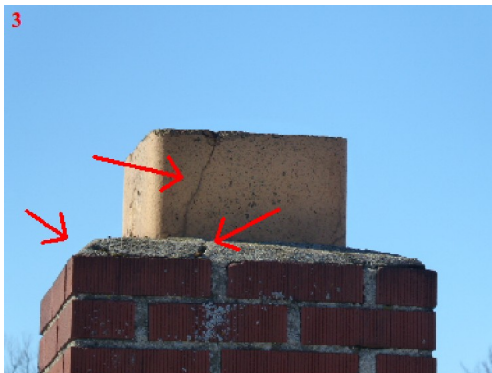
There have been past mortar joint repairs made to the chimney and overall its condition appears to be satisfactory.

There is a crack visible in the top section of the clay flue liner as well as the masonry crown. The installation of a rain cap is advised as a way to limit moisture entry into the chimney flue that can have a detrimental affect on integrity. Any cracks in the masonry chimney crown / cap should be sealed for similar reasons.

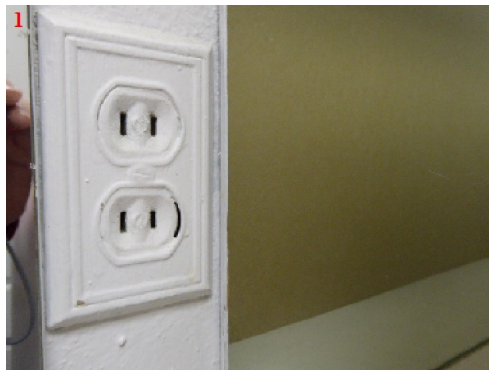
Receptacles in damp locations including restrooms should be GFCI type. Replacement is advised with any planned electrical upgrades.

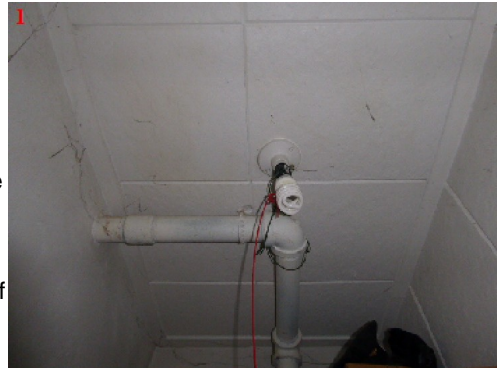
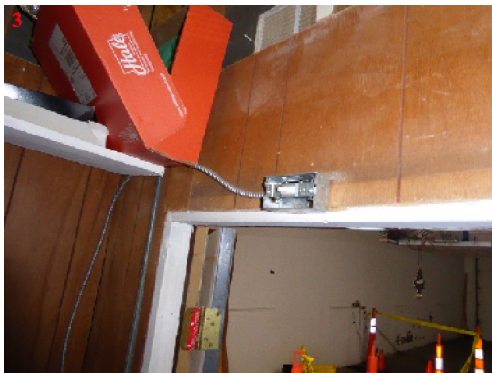
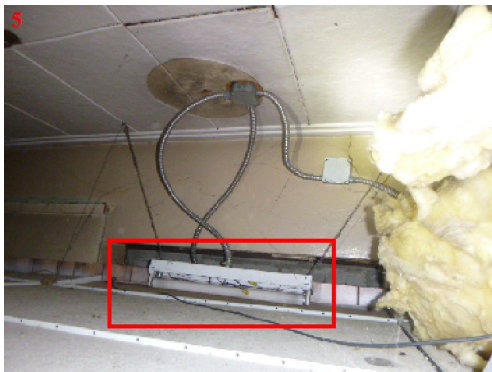
There is a junction box above the ceiling in the northwest office (above the stained ceiling tile) that may be getting wet when the roof and/or gutter leaks. (photos 6 & 7) This needs to be addressed by a qualified electrician.

Extension cord wiring should be eliminated and replaced with permanent circuits, connections/splices should all be enclosed in a covered junction box. Where older wiring has been modified to suit the current needs for the occupants, it is imperative that the work be focused on safety of the occupants.

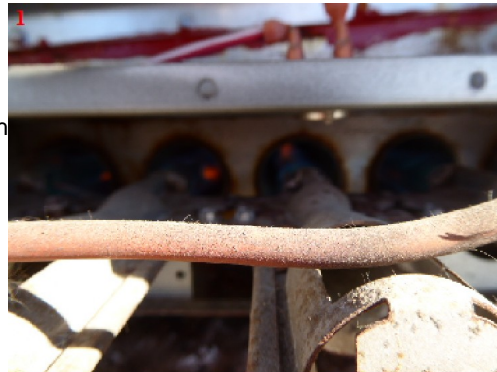
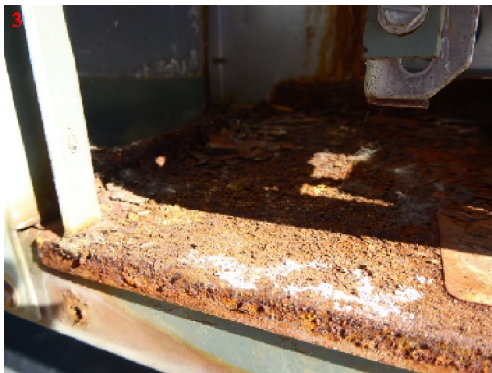
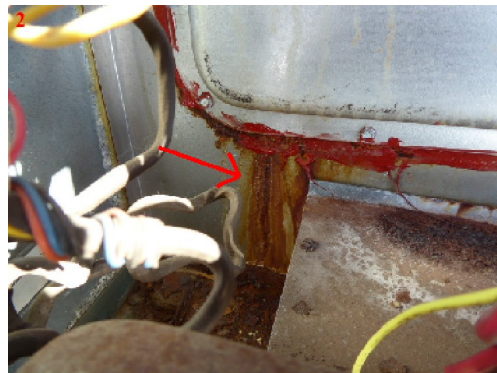
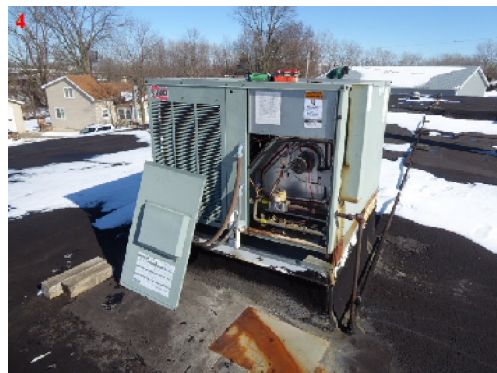
It appears the heat exchanger may have been replaced in the rooftop unit in the past few years however there are other aged components that may require repair or replacement in the near future based primarily on their age. Rust and scale build up on and near the heat exchanger shroud needs to be closely monitored. With rooftop HVAC units there is an approximate design life or useful life expectancy somewhere around 20 to 25 years.

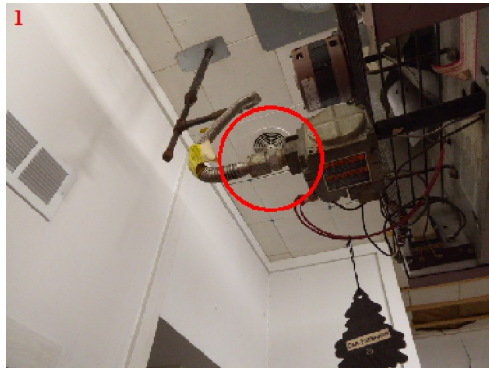
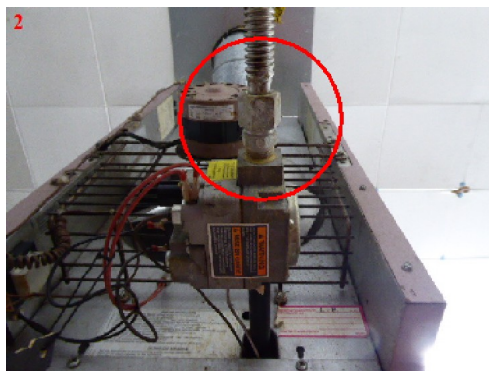
Immediate repair is needed for a suspected gas leak. There is a slight gas odor at the south garage heater ignition control connection that poses a safety concern. It is suspected that the leak is at the fitting identified in the photos but the entire gas line connection should be evaluated. This issue was brought to the attention of the Trustee on site at the time of the assessment.

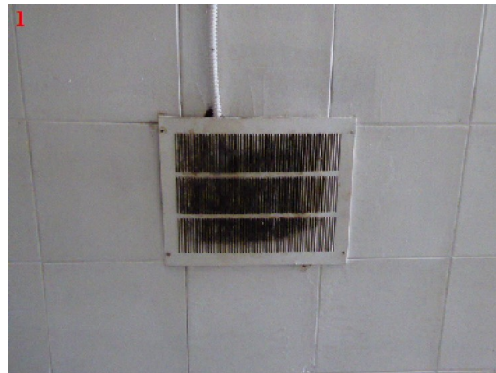
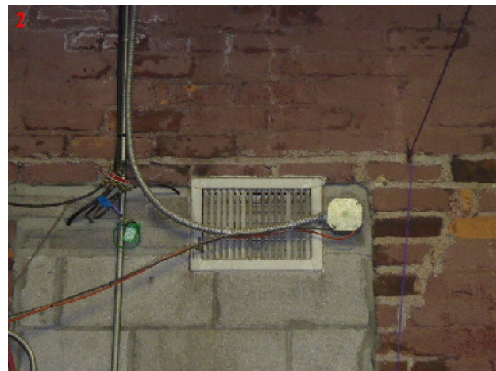
Dirty / clogged ventilation louvers in the south garage in particular should be cleaned and maintained on a regular basis.

There is a vent grill installed in the north garage separation wall (photo 2). Because of equipment in the way and blocking access, it was not determined if this vent is for exhaust into the chimney and out or for another purpose. If connected to any other duct system that runs between the building sections, including heating and cooling ducting, it should be isolated or blocked so as not to allow potentially harmful fumes or vapors from the service shop to be carried through the building.

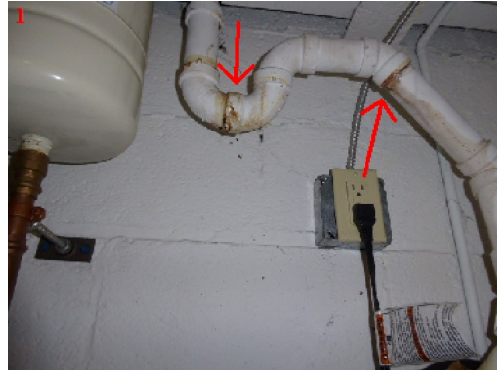
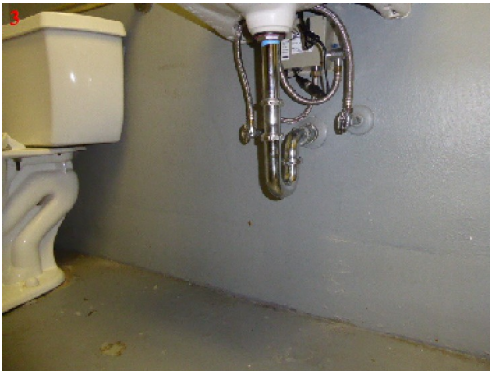
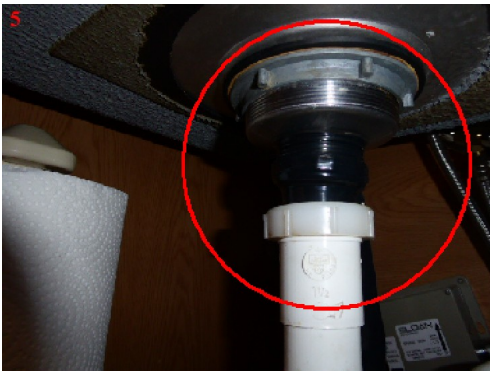
There is evidence of past leakage (staining) at various sink drain traps. No moisture was observed at the time of the onsite assessment. Amateur repair / installation using electrical tape was observed at the coffee area sink.

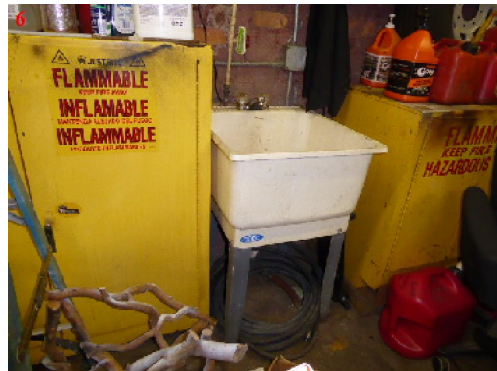
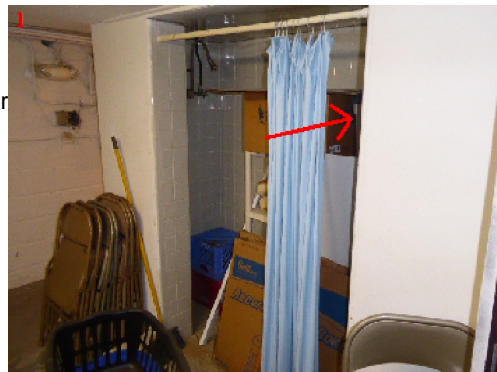
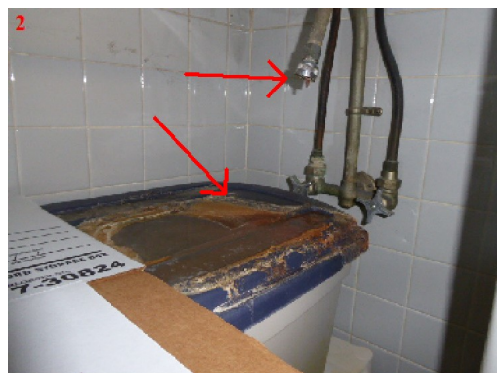
#### Active Leakage - General Advisory

Note that with any evidence that leakage has occurred, previously or active, some degree of damage to surrounding areas and materials, whether concealed or not, is always possible.

Repair of any leakage noted should be performed by a qualified contractor and treated as a priority.

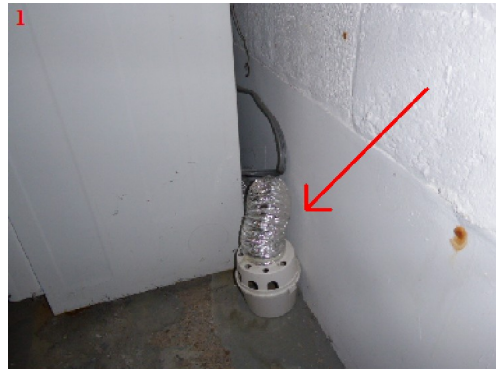
The dryer is currently vented indoors and ultimately should be vented to the exterior.

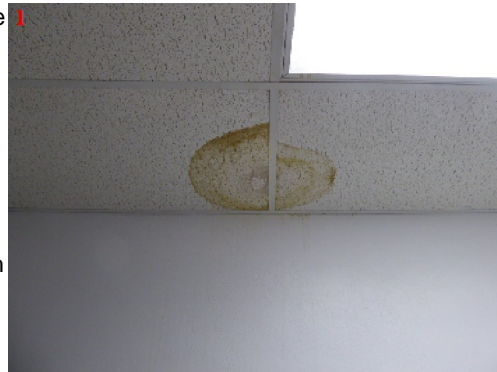
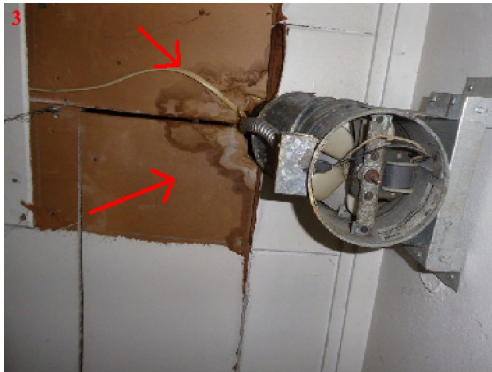
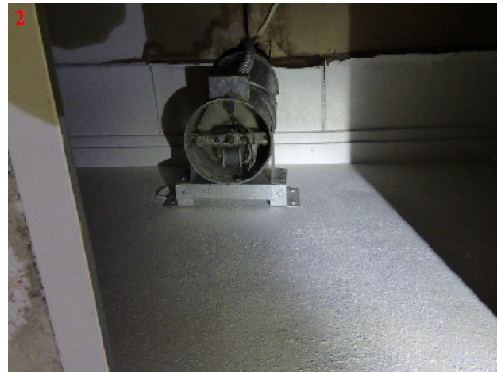
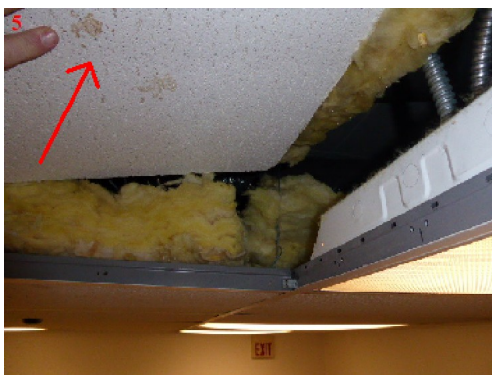
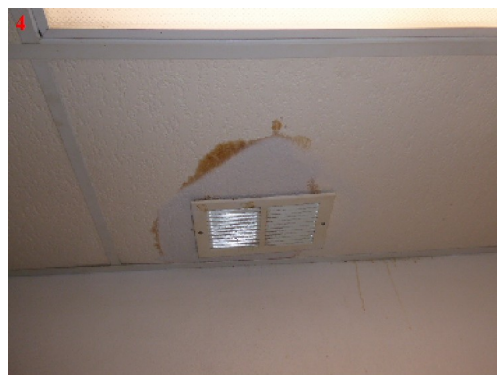
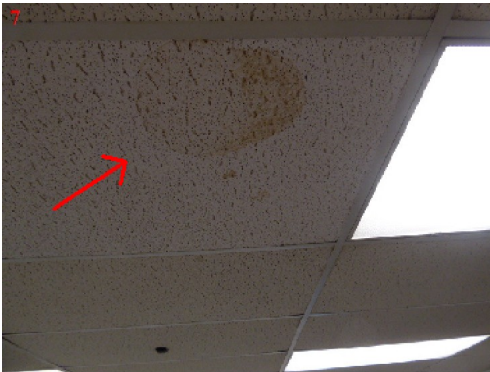
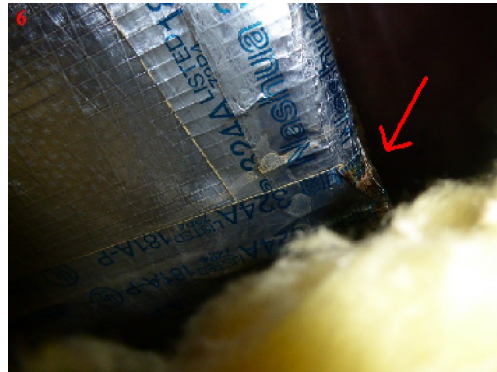
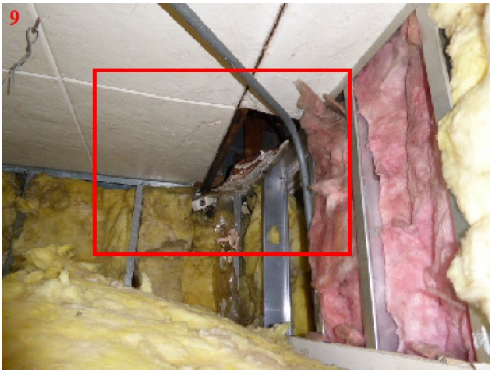
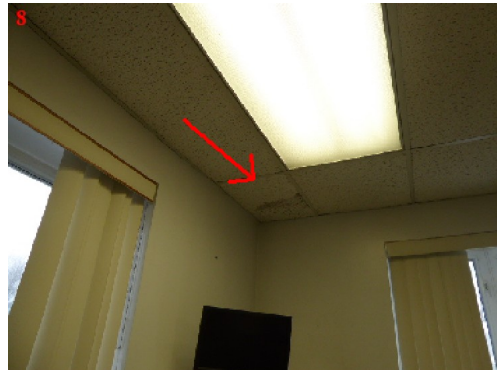
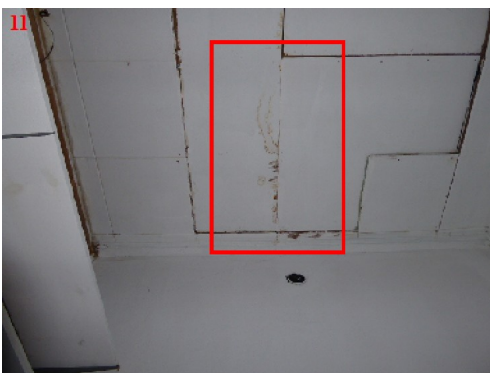
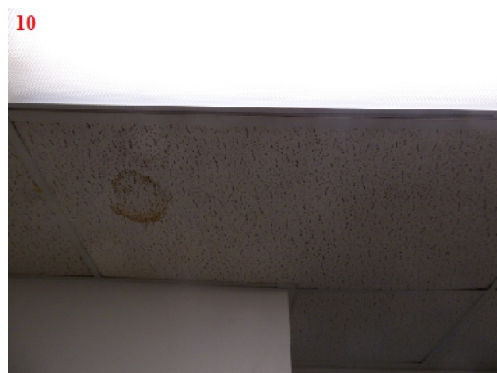
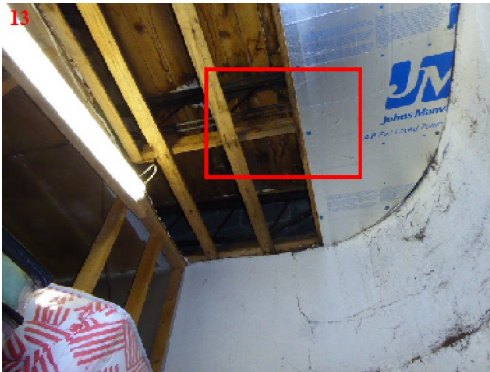
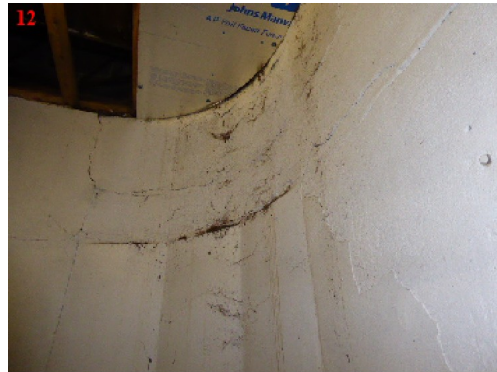
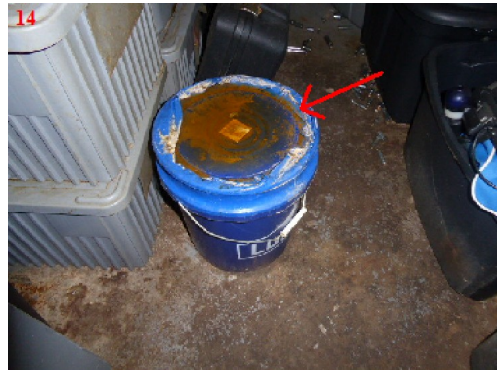
### **Monitor / Maintain** Interior Ceilings - Suspended Ceiling, Dry Wall, Plaster, Acoustic Tile, Exposed Steel Panel Roof Deck, Damaged Suspended Ceiling Tile

Multiple suspended ceiling tile have stained surfaces. Staining in the north restroom ceiling was damp to the touch at the time of the inspection. This moisture appears to be related to a leak at the exhaust fan installed above the ceiling in the restroom. This may be a roof related leak due to staining on the visible underside of the roof deck at the penetration. Staining in other sections of the building appear to be from a combination of condensation dripping from ductwork and roof leakage.

Other stained ceiling tile did not feel damp to the touch. Consult with the IR report for additional detail.

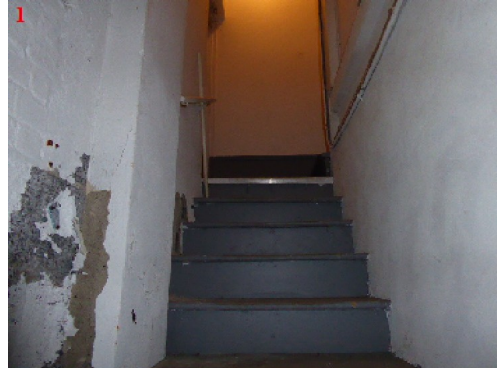
#### Stairways - Missing Hand Railings

There was a missing section of railing on the basement stairs as well as the stairs between the main common meeting room and the police officer offices.

Railings are generally required where there are three or more stair rises. For safety of those using any of the building's stairways, railings should be installed.

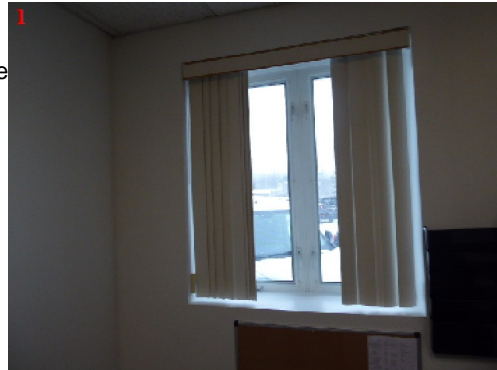
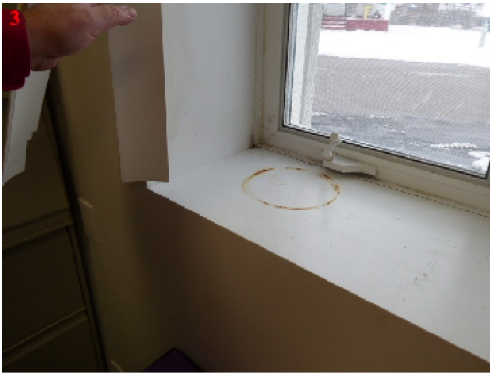
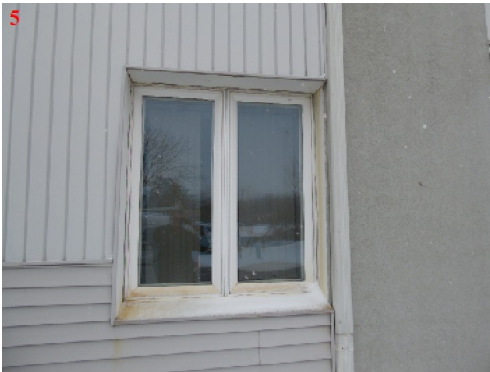
Some windows were not able to be opened due to obstructions or the fact that using normal force, they would not open. Windows that are seldom if ever opened can become stuck. All windows should be made operational to offer a source of secondary egress in an emergency and a source of fresh air.

Windows on the north wall show signs of leakage and surface damage to the sill area. These stained areas were dry at the time of the on site assessment.

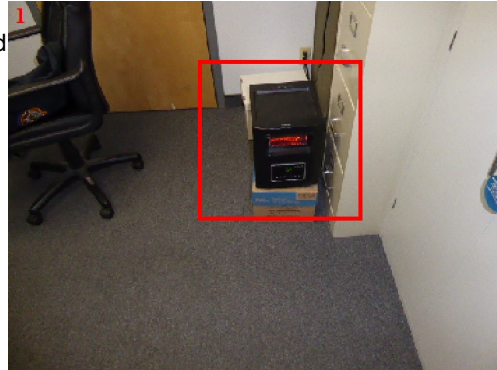
### Supplemental Climate Control Observed - General Commentary

When supplemental climate control is observed, or even dedicated "portable" climate control is installed outside of the main heating and or cooling plant, it could be an indication of less than ideal coverage and distribution from the main system / systems.

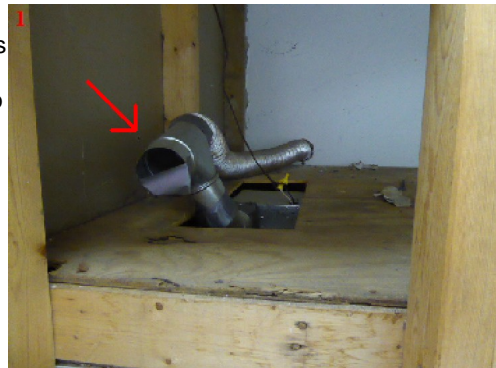
### Interior Room Exhaust Routing - Terminates Within Plenum Space

There is room for improvement for the exhaust fans for the restrooms. From the "closet" accessible in the south garage, there is access to the vent piping. Noting that the restrooms in this case do not have showers that generate warm moist air, it is not as critical to vent the exhaust fans to the exterior. They are mainly used for air movement/odor removal.

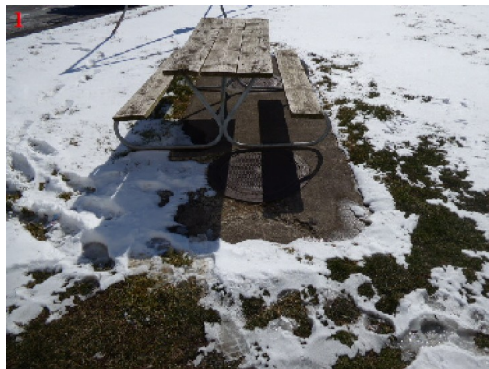
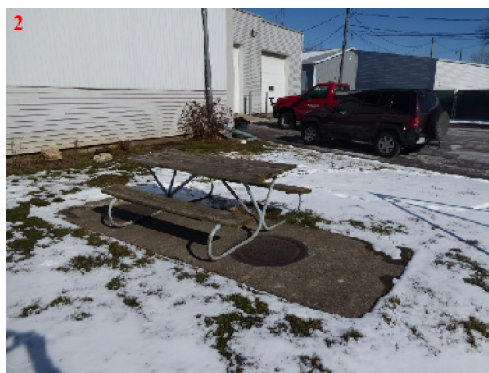
#### Underground Storage Vessel - General Comment

Identification of an underground storage vessel by visual inspection only is an inaccurate assessment. The inspector will note evidence of the potential for tanks / vessels that appears related to an underground vessel. It is not known if the storage tank off the south side of the building is abandoned or not. Based on building records, it is presumed that the building is on city sewer service and that the suspected underground vessel may be related to an old on site sewage system and / or grease collection and separator system.
